**Flood Control Project Maintenance
Levee Inspections**
LMA District Cover Sheet
Spring 2011 Levee Inspection Results

Sutter Maintenance Yard East-West Interceptor

Levee Inspection Report By Mile - Spring 2011

Waterway							Bank	Unit Miles	Inspection Start/End	Inspector
Unit No. 01 West Levee							Right	1.75	05/03/2011 05/03/2011	Bob Duffey

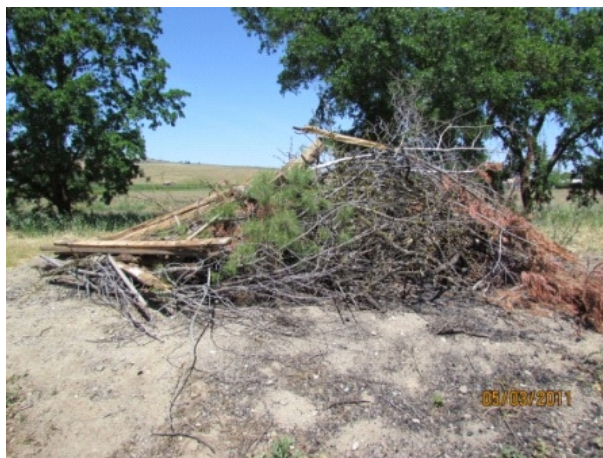
Levee Mile Report Line	1
Start Levee Mile	0.22
End Levee Mile	0.22
Location	Land Side
Category	Earthen Levee
Item	Encroachments

View of the pruning along the levee.

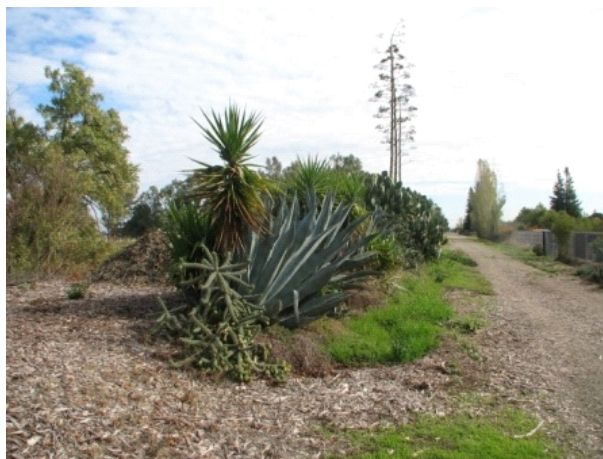
Levee Mile Report Line	2
Start Levee Mile	0.23
End Levee Mile	0.25
Location	Crown
Category	Earthen Levee
Item	Encroachments

View of cactus and pine trees along the land side toe.

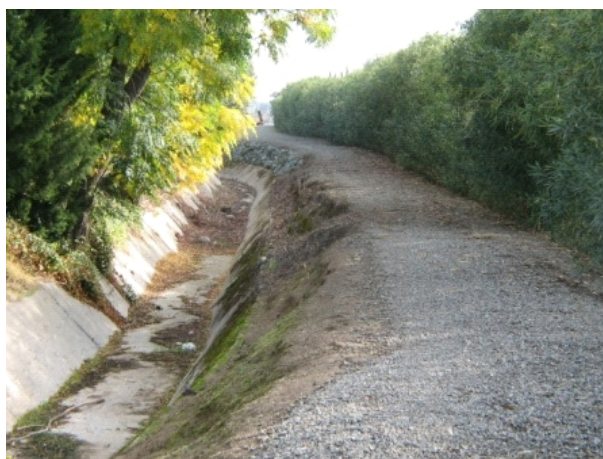
Levee Mile Report Line	3
Start Levee Mile	0.62
End Levee Mile	0.65
Location	Water Side
Category	Earthen Levee
Item	Erosion / Bank Caving

View of the erosion along the concrete ditch on the waterside slope.

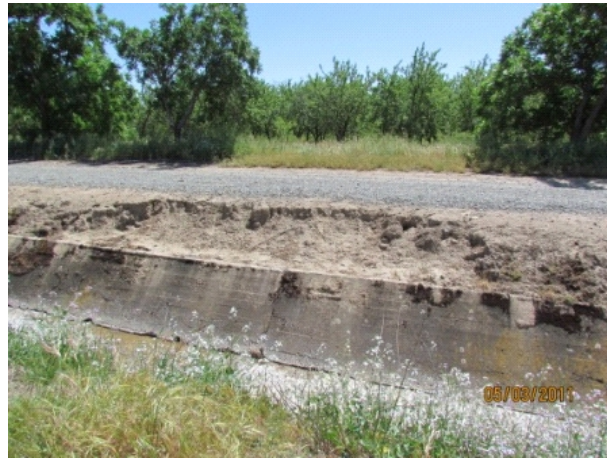
Levee Mile Report Line	4
Start Levee Mile	1.23
End Levee Mile	1.24
Location	Water Side
Category	Earthen Levee
Item	Erosion / Bank Caving

View of the erosion along the concrete canal.

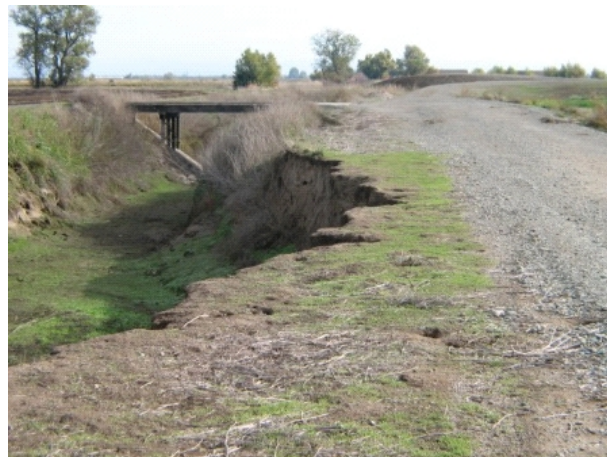
Levee Mile Report Line	5
Start Levee Mile	1.67
End Levee Mile	1.67
Location	Water Side
Category	Earthen Levee
Item	Erosion / Bank Caving

View of the erosion along the waterside slope.

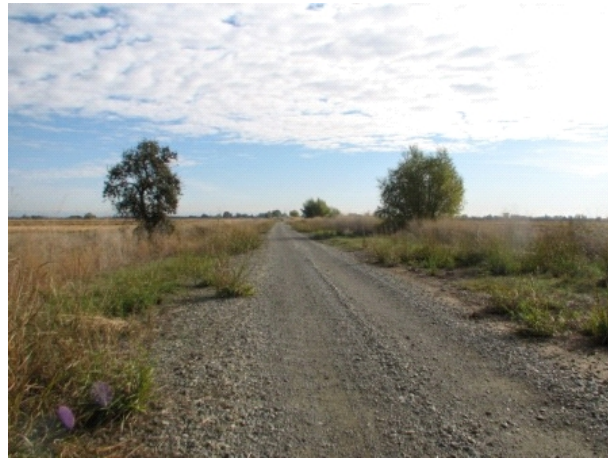
Levee Mile Report Line	1
Start Levee Mile	0.55
End Levee Mile	1.55
Location	Land Side
Category	Earthen Levee
Item	Vegetation

View of the grasses and vegetation on both slopes.

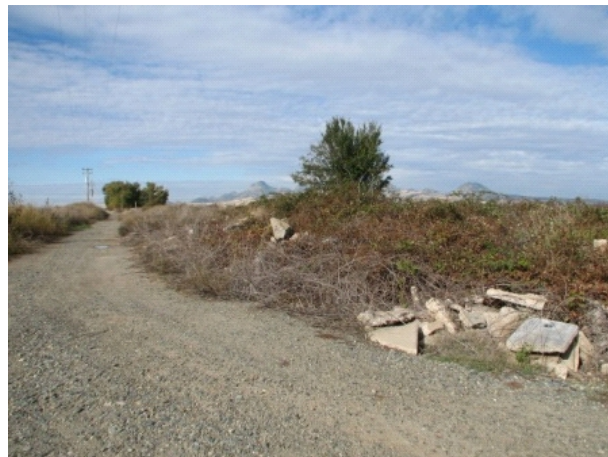
Levee Mile Report Line	3
Start Levee Mile	1.43
End Levee Mile	1.55
Location	Land Side
Category	Earthen Levee
Item	Encroachments

View of the pile of broken concrete next to the levee.

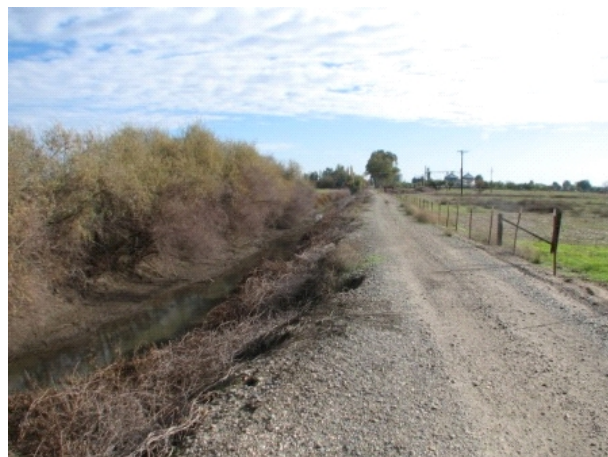
Levee Mile Report Line	4
Start Levee Mile	1.54
End Levee Mile	1.93
Location	Water Side
Category	Earthen Levee
Item	Erosion / Bank Caving

View of the erosion along the waterside slope.

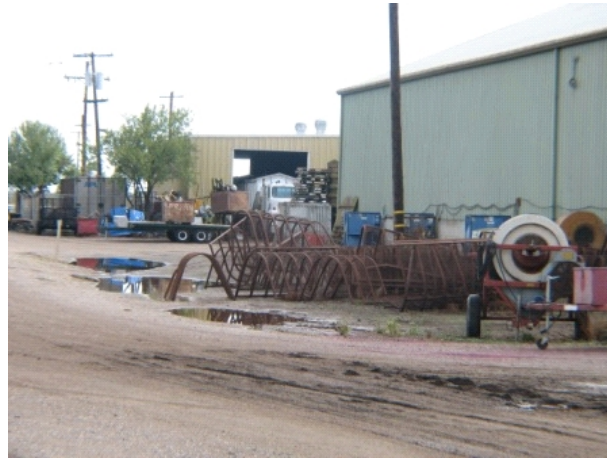
Levee Mile Report Line	5
Start Levee Mile	1.92
End Levee Mile	2.04
Location	Land Side
Category	Earthen Levee
Item	Encroachments

View of the equipment and buildings next to the landside berm.

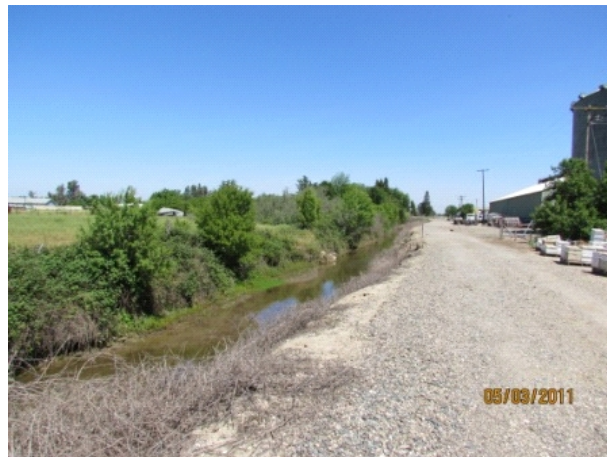
Levee Mile Report Line	6
Start Levee Mile	1.95
End Levee Mile	1.98
Location	Land Side
Category	Earthen Levee
Item	Erosion / Bank Caving

View of the erosion along the W/S slope.
